### Inspection Report

#### Minerals Regulatory Program

**Mine Name:** Torrey Sandstone  
**Operator Name:** Star Stone Quarries, Inc.

**Permit number:** M0550016  
**Inspection Date:** April 5, 2006  
**Time:** 4:50-5:20 PM

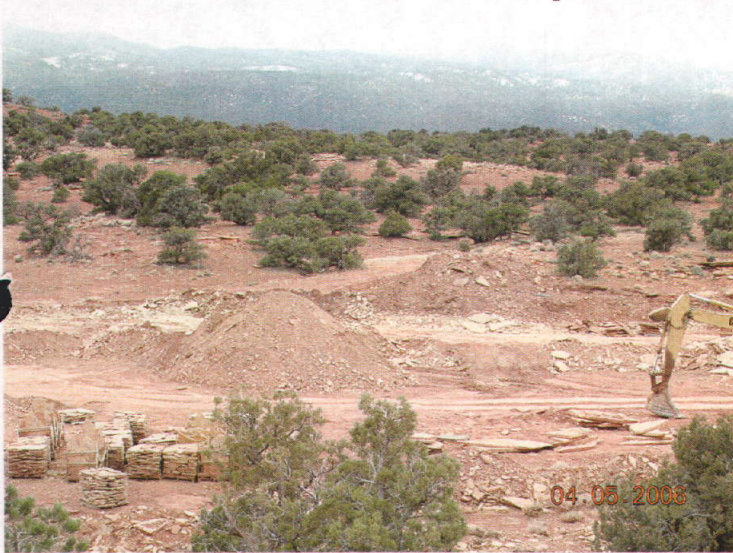
It appears the mine has expanded slightly or is on the verge of expanding to the south, and there is soil (or at least unconsolidated material) that could be salvaged from this area (Photo 1). It does appear the operator has salvaged some soil in this area.

**Photo 1.** View looking toward the south end of the quarry. The operator is processing material from this area (Photo 2). Note the unconsolidated material that has been or could be salvaged.

The operator needs to continue to salvage as much soil as available. Although the plan has yet to be approved, I recommend that the operator install the sediment trap.

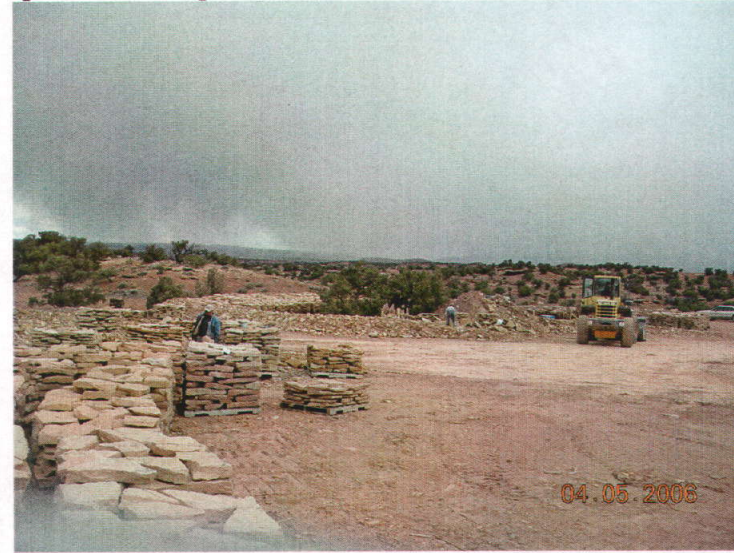
**Photo 3.** Processing area.

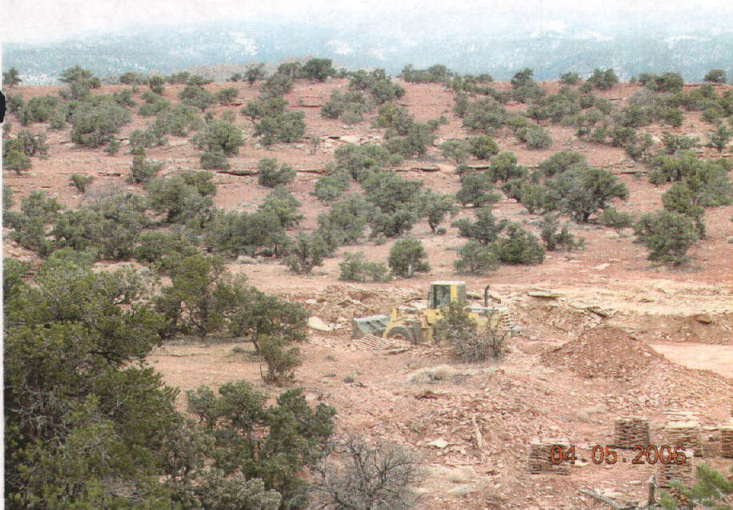
The workers were using a front end loader to take material from the south portion of the mine (Photo 2) to a centrally located area where they would split the stone and load it on pallets.

**Photo 2.** Loading material from the south part of the quarry.

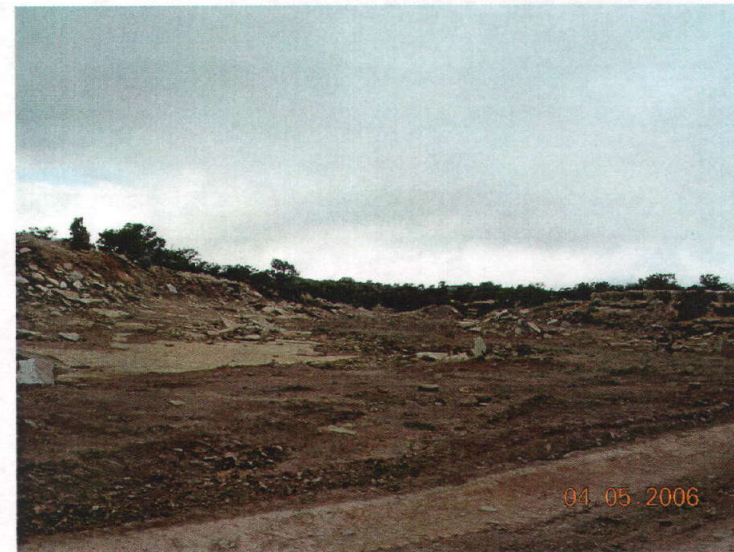
Some of the mining is being in an ephemeral drainage channel (Photo 4). In the plan that has not yet been approved, the operator commits to installing a sediment trap downstream from the quarry.

**Photo 4.** This photo, though dark, shows the drainage channel going through the southern portion of the area.
